BULLETIN TITLE: ELEVATOR CONTROL STUCK			
	CLASSIFICATION: SAFETY ALERT			
BULLETIN NUMBER: ALL-SA-3-0-5-0001-2017		ALL-SA-4-0-5-0001-2017 ALL-SA-5-0-5-0001-2017		
ALL-SA-4-0-5-0001-2017				
Letecká 255 686 04 Kunovice Czech Republic	Tel.:+420 773 984 338 info@brmaero.com www.brmaero.com	Date of issue: 05.10.2017 Date of effect: 05.10.2017	Revision no.: Initial issue Date of rev.: -	Page: 1 Pages: 10

PICTURE OF ELEVATOR SERVO STUCK ROD

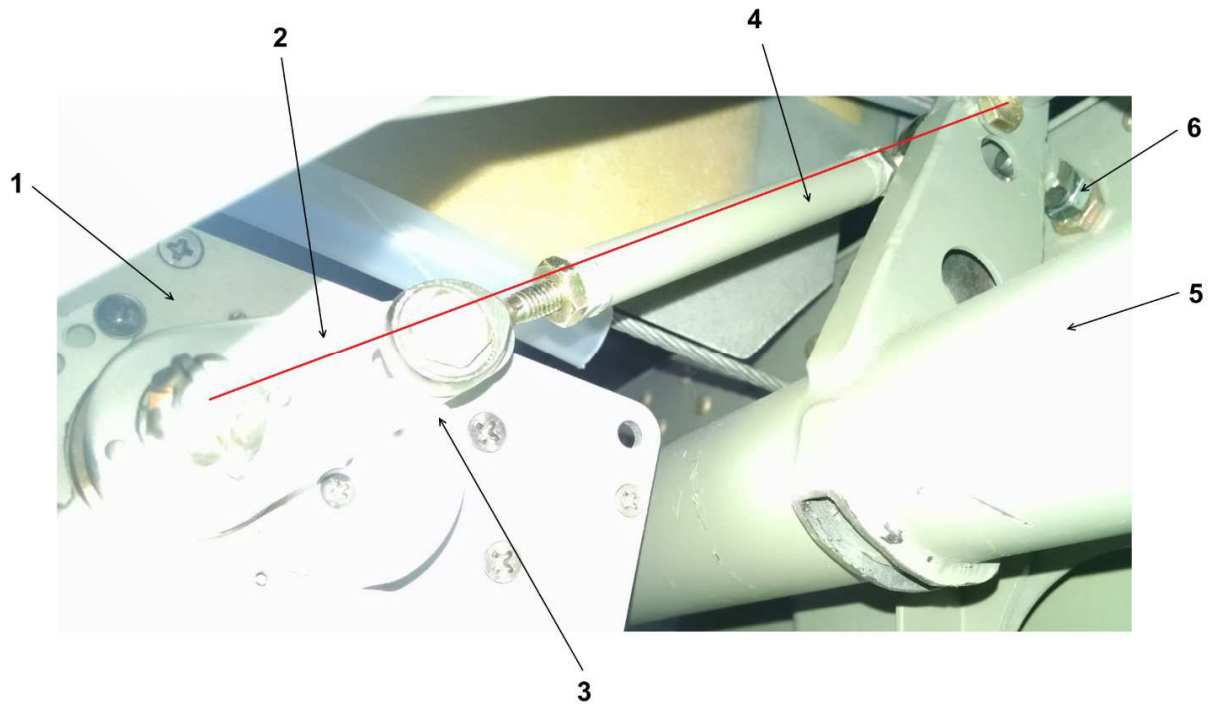
Figure 1

The BRISTELL airplanes fitted with an autopilot and any of Rotax 912 iS, iS Sport, Rotax 914 engines must have (due to space reasons - fuel installation with 2 fuel pumps) the elevator servo rod connected to the upper arm on the control stick torsion tube (at hand control upper stop). Elevator control stuck has occurred during taxiing on one of the airplanes in operation. It was then found, that the cause was jamming of an autopilot servo rod in a dead position, see Appendix 1.

1 – Autopilot elevator control servo	2 – Servo arm
3 – Front stop of servo arm	4 – Servo rod (jammed in dead position between servo arm and arm on control sticks torsion tube)
5 – Control sticks torsion tube	6 – Elevator upper stop in push direction

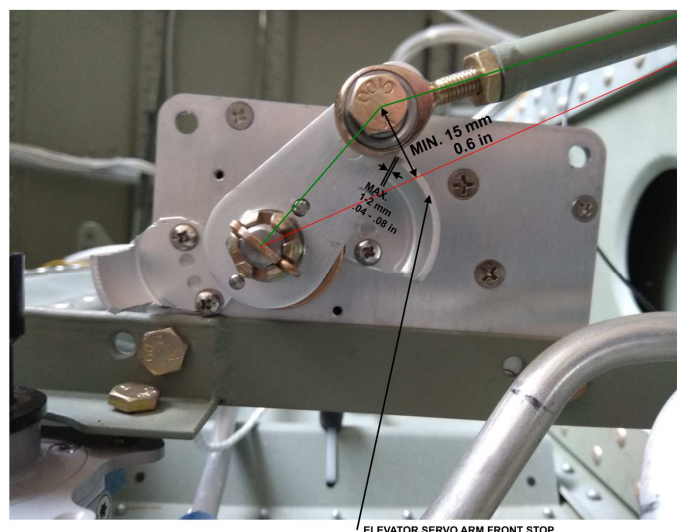
The elevator servo rod must not achieve dead position, when the rod will be aligned in a straight line with the servo arm (180° angle – see the red line on Figure 6 or Figure 1).

The angle between servo rod and servo arm must be significantly less than 180° and such, that the distance of joint center from straight line will be 15 mm (0.6 in) at minimum (see green polygonal line on Figure 6).

The elevator servo arm must simultaneously touch its front stop, see Figure 6.

8. If everything is OK according to step 7, then proceed with step 15 and subsequent.
9. If the rod may reach its dead position and/or the joint distance from the straight line is less than 15 mm (0.6 in) or if the servo arm simultaneously does not touch its front stop (gap is more than 1-2 mm (0.04-0.08 in)), then it will be necessary to elongate rod length and move/adjust the servo arm front stop.

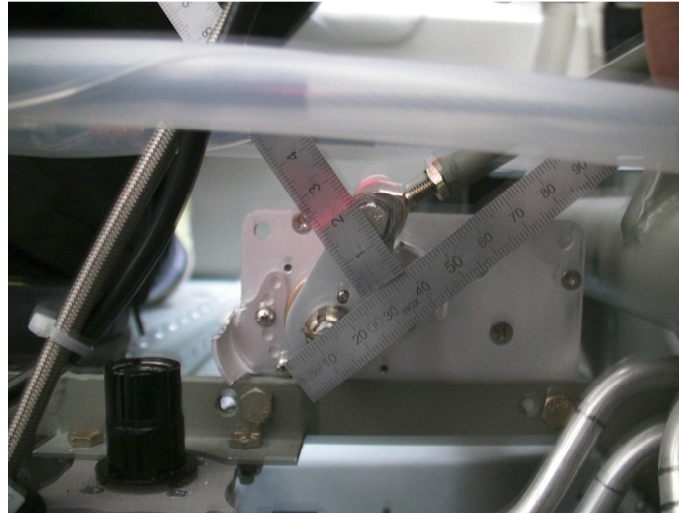
Figure 7

Two suitable rules may be used to measure the distance, see Figure 7.

12. If the rod length still needs to be adjusted, then repeat the procedure in previous step .
13. Re-install the servo arm front stop back on the servo body so that the servo arm will touch the stop with fully pushed control sticks (see Figure 7).

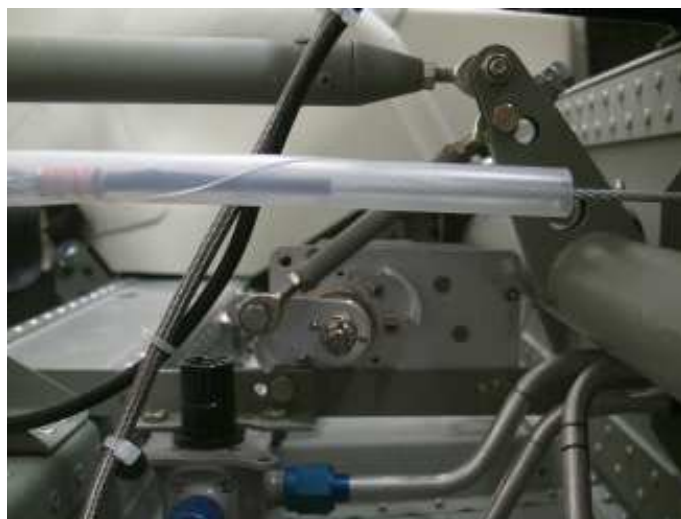
Figure 9

15. Pull the control sticks fully aft (see *Figure 8*) up to the pull stop (bottom stop on the wing main spar) and check mutual position of the servo rod and servo arm. The rod and arm may not be aligned in a straight line (dead position) and servo arm should touch the rear stop (gap max. 1-2 mm), see *Figure 9*.

Note: If necessary, when the servo arm is hitting the stop edge too early after stop movement to its new position, the stop edge may be trimmed using a file or snips.
