In Uherske Hradiste 1<sup>th</sup> November 2018

Overview: This letter authorizes Sport Flying USA Services, LLC. 500 Airport Road Suite D. Lititz, Pennsylvania 17543 to repair N593BL S/N 093/2014 left and right side skin next to landing gear box with an 0.032 aluminum doubler on the exterior of side skin and 3/4" aluminum angle on the interior of the side skins installed vertically to reinforce areas that had been previously damaged by a hard landing. Cracks in aluminum side skin should be stopped drilled to prevent further cracking. Aluminum doubler and 3/4" aluminum angle will be 1/8" Avex riveted and adhered in to place with Emfimastic PU 50. Repair should then be covered with corrosion resistant primer. Wing root skins riveted back into place. Wing root composite fillets adhered back into place with Emfimastic PU 50. Paint to Spec. This Letter of Authorization (LOA) is approved only for **BRM Aero Bristell SLSA S/N 093/2014**. A log book entry in the aircraft logbook for the work completed is required.

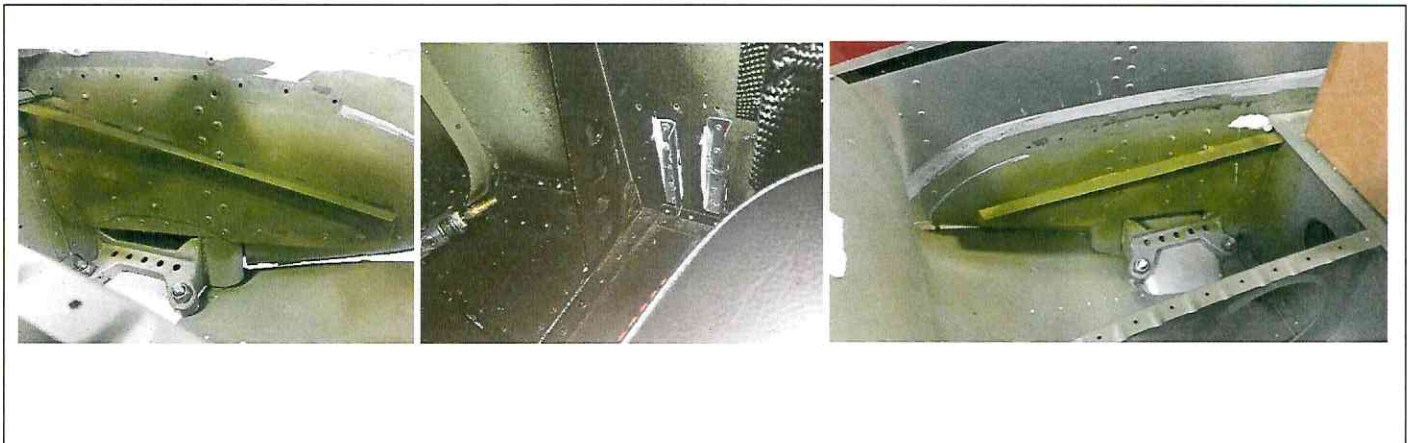
*Reference photos and notes below for the repair underneath wing root skin.*
