**Evektor SportStar Modification
Bulletin SportStar-002a Alternate Compliance**

**AvSport SI-EVSS-02
12 November 2012**

<p>OPTIONAL SERVICE INSTRUCTION</p>
--

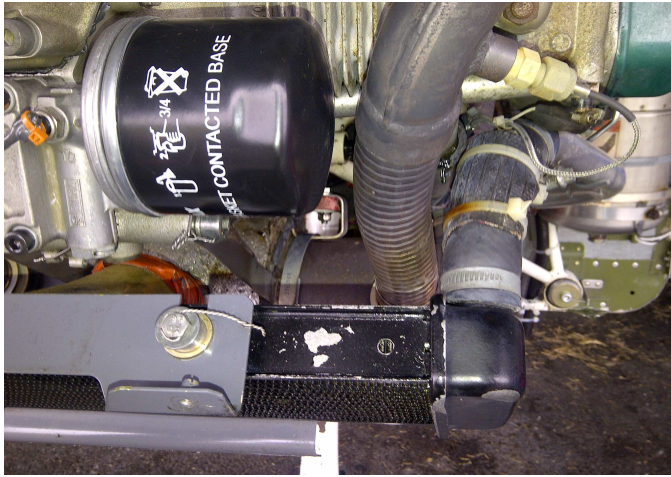
Due to engine left radiator rubber hose thermal damage caused by insufficient clearance between the radiator hose and the left front cylinder exhaust pipe, Evektor in 2005 issued Mandatory Bulletin No. Sportstar-002a, requiring verification of exhaust pipe clearance, recurrent with every replacement of the oil filter. Compliance has required separating the left front cylinder exhaust manifold elbow from the cylinder head during every oil change. This procedure has necessitated repeated flexing of the bendable section of the exhaust pipe, inducing stresses in LH Front Exhaust Tube PN E6 10-16 01, reducing the reliability of said component. Field experience has shown the exhaust pipe to be subject to failure from cracks when repeatedly flexed, leading to exhaust system leaks. The problem is exacerbated by the use of leaded fuel (100LL), due to vaporized lead condensing on, and thus coating, inside exhaust system surfaces.

Pre-modification clearance

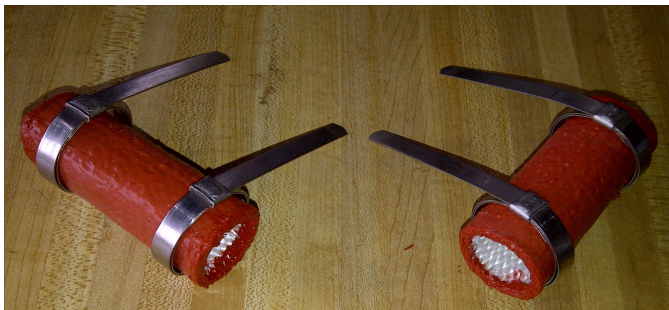
Firesleeve sections prepared

1. Remove engine cowling
2. Prepare two 10 cm lengths of firesleeve
3. Seal ends of firesleeve with end dip or RTV to prevent fraying and fluid wicking
4. Slide two firesleeve clamps onto firesleeve
5. Drain engine coolant
6. Remove left side rubber hose from radiator by loosening hose clamp
7. Slide firesleeve over rubber radiator hose
8. Reinstall hose onto radiator and secure hose clamp
9. Slide one firesleeve clamp to within 5 mm of each end of firesleeve
10. Secure firesleeve to hose by tightening both firesleeve clamps
11. *Optionally:* Repeat steps 6 through 9 on the right side rubber radiator hose
12. Refill radiator and cooling system with approved coolant
13. Reinstall engine cowling

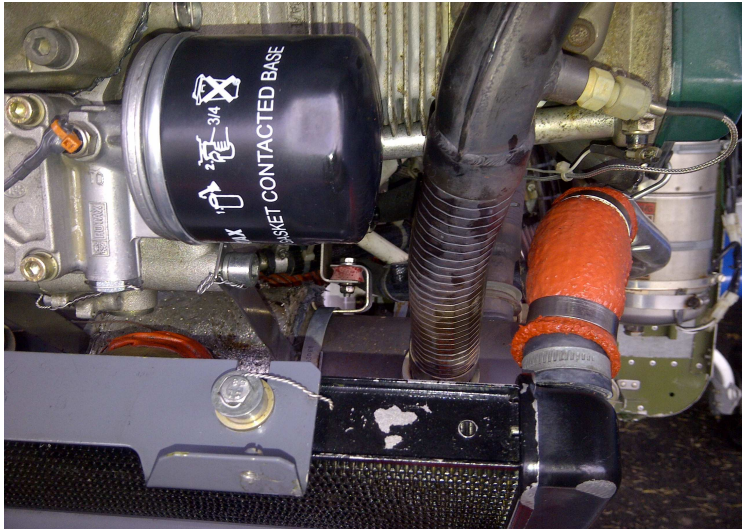
Post-modification clearance – left side

Summary: The firesleeve adequately protects the radiator hose from heat damage.
All objectives of this modification have been satisfied.

AvSport hereby recommends an alternative method of compliance with Evektor Mandatory Bulletin No. Sportstar-002a, in order to eliminate the requirement for removal, flexing, and reinstallation of the left front exhaust pipe at every oil and filter change. The modification involves installing firesleeve over the vulnerable rubber radiator hose, protecting it from thermal damage and thus reducing the required spacing between the hose and the exhaust pipe. A new position of the exhaust pipe is then established, which permits oil filter replacement without requiring the pipe's repeated removal and reinstallation. Evektor has on 09 November 2012 issued a temporary Letter of Authorization, to facilitate testing of this proposed solution on SportStar s/n 2006-0810, registration N66AV, currently with 1316.5 total hours in service.

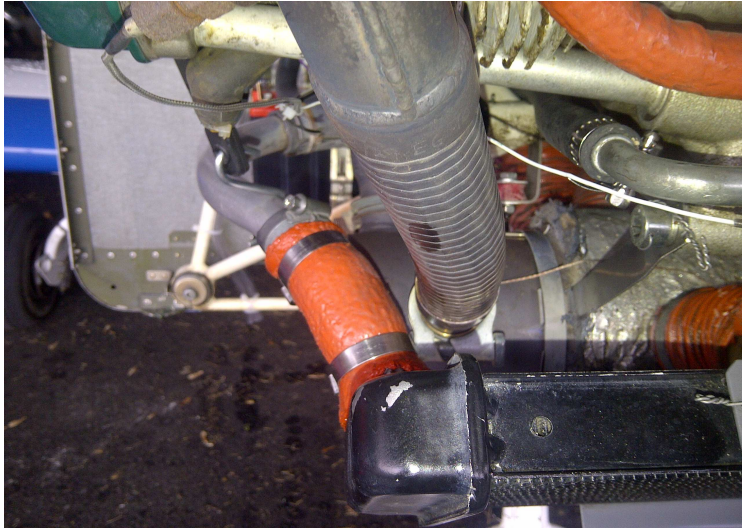
Clearance – right side (mod optional)
